INSPECTION REPORT

For the Property at:
123 ANY STREET
MY TOWN, AB T0A3A0

Prepared for: SAMPLE REPORT
Inspection Date: Tuesday, May 1, 2012
Prepared by: Jeff Odowichuk

RE: Report No. 1003, v.0
123 Any Street
My Town, AB
T0A3A0

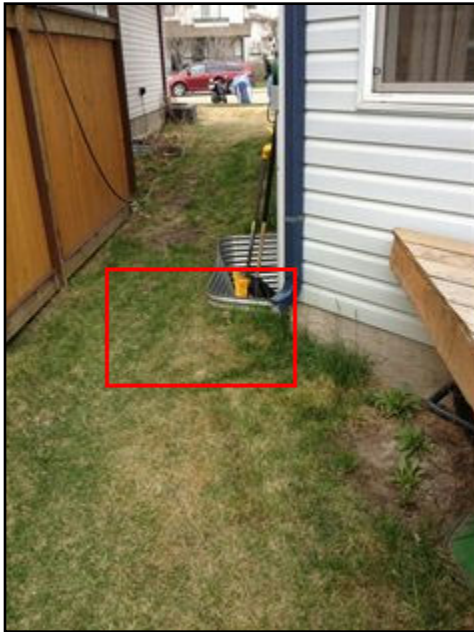
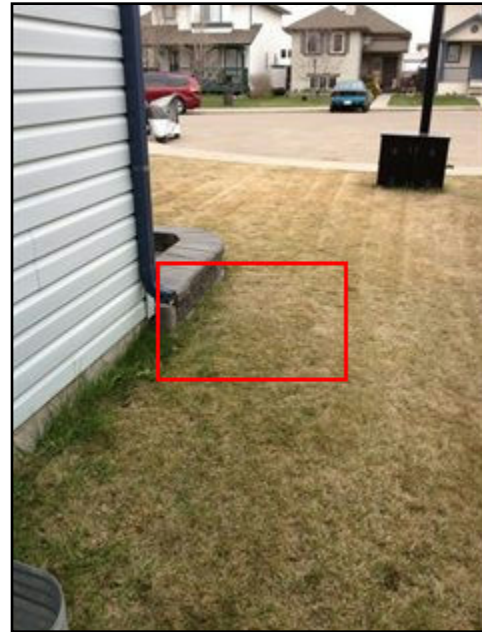
1. Condition: • [Missing](#)

Implication(s): Chance of water damage to contents, finishes and/or structure

Location: Southwest & Northeast

2. Missing

3. Missing

Task: Replace

Time: Immediately

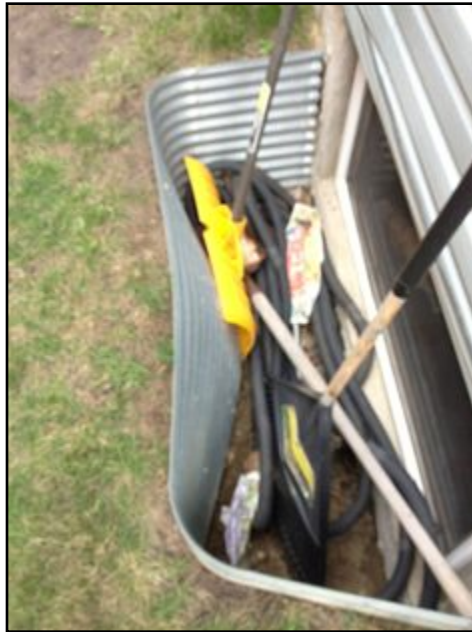
2. Condition: • [Damage](#)

Window well has been pushed in, Recommend repair

Implication(s): Chance of water damage to contents, finishes and/or structure | Material deterioration

Location: West Exterior

4. Damage

Task: repair

Time: 6 months

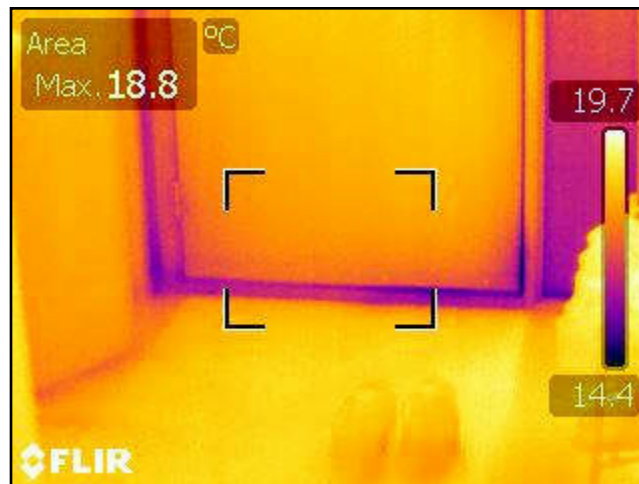
3. Condition: • [Air leaks](#)

Implication(s): Chance of damage to finishes and structure | Increased heating and cooling costs

Location: Front

5. Air leaks

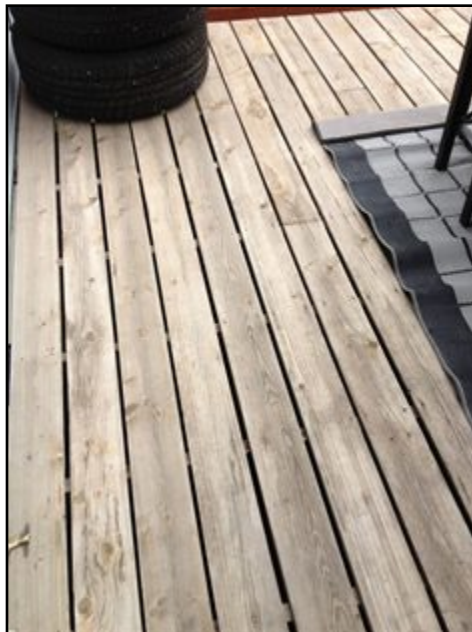
4. Condition: • [Paint or stain needed](#)

Implication(s): Cosmetic defects | Shortened life expectancy of material

6. Paint or stain needed

Task: Improve

Time: Less than 1 year

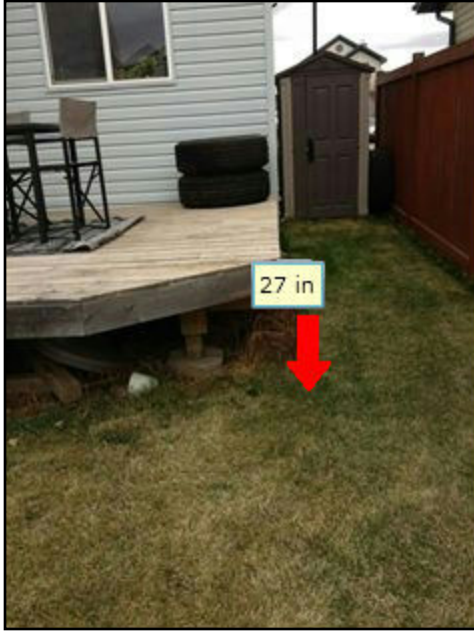
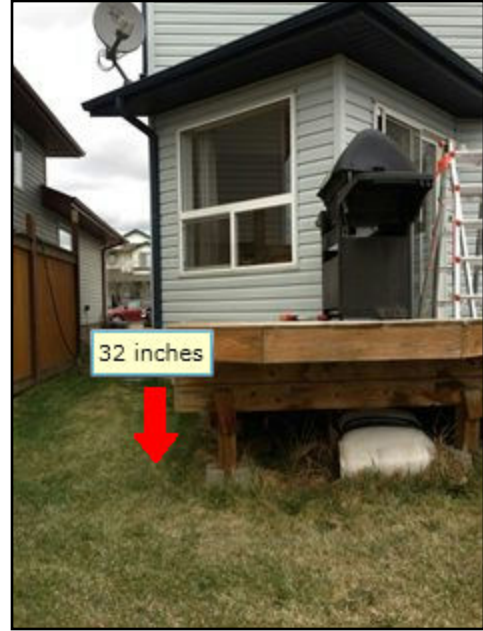
6. Condition: • [Missing](#)

Decks that are more than 24 inches off the ground should be protected by guardrail.

Implication(s): Fall hazard

Location: Rear

7. Missing

8. Missing

Task: add

Time: immediately

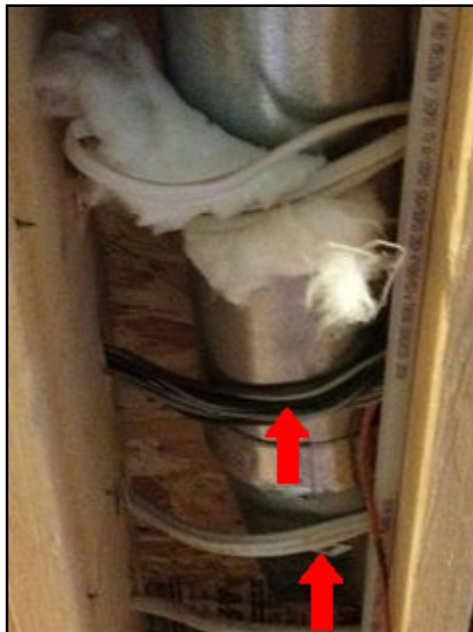
7. Condition: • [Too close to ducts, pipe, chimneys, etc.](#)

Implication(s): Electric shock | Fire hazard

Location: Basement Furnace Room

11. Too close to ducts, pipe, chimneys, etc.

Task: Repair

Time: Immediately

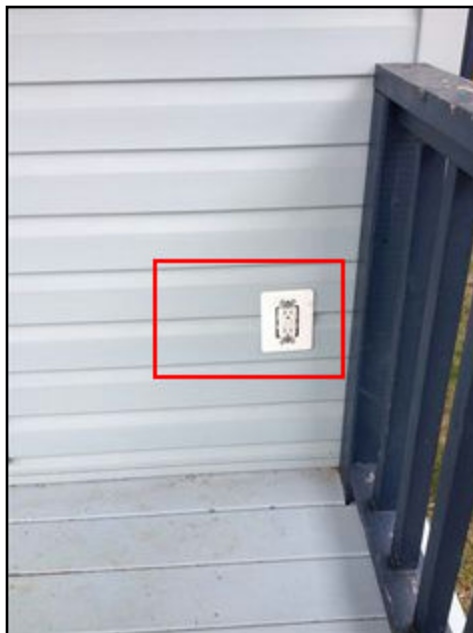
8. Condition: • [Missing](#)

Implication(s): Electric shock

Location: Front

12. Missing

Task: Replace

Time: Immediate

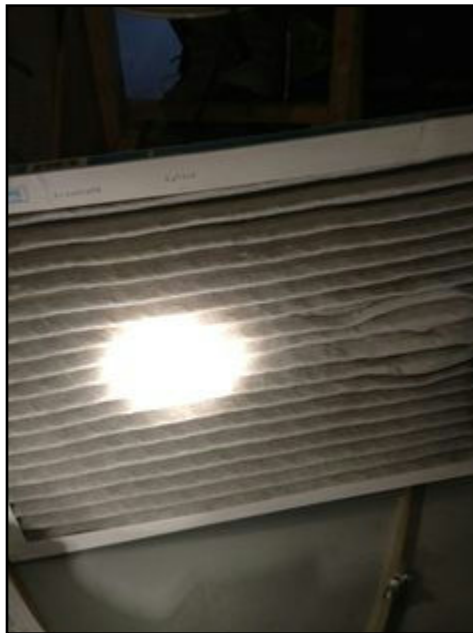
9. Condition: • [Dirty](#)

Implication(s): Increased heating costs | Reduced comfort

13. Dirty

Task: Replace

Time: Immediate

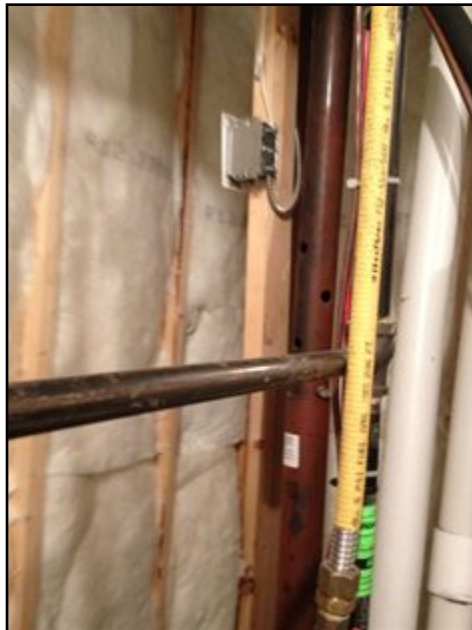
- Continuity not verified

Insulation only visible in furnace room, Has vapor barrier. Balance of home has drywall coverings.

14. Continuity not verified

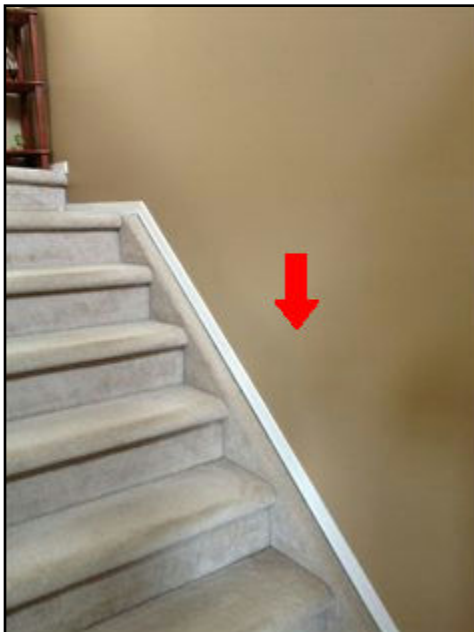
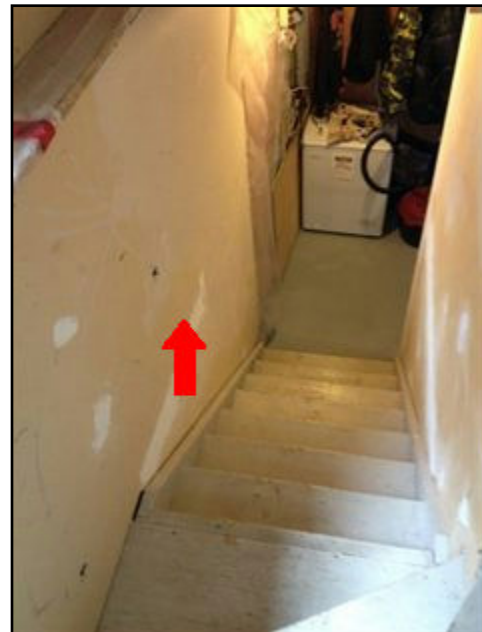
10. Condition: • [Missing](#)

Implication(s): Fall hazard

Location: Basement Second Floor

15. Missing

16. Missing

Task: Improve

Time: Immediate

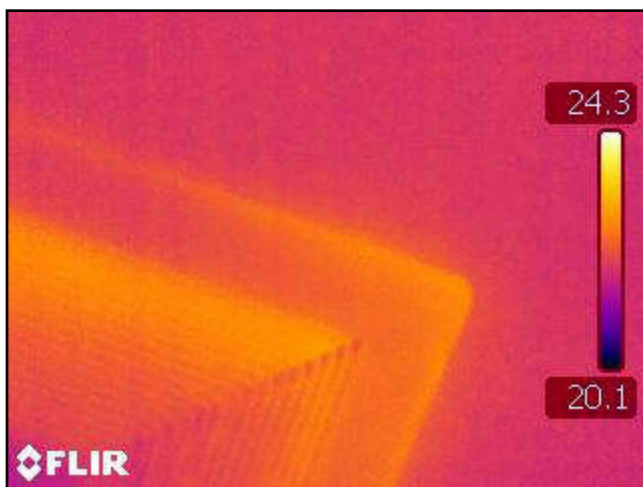
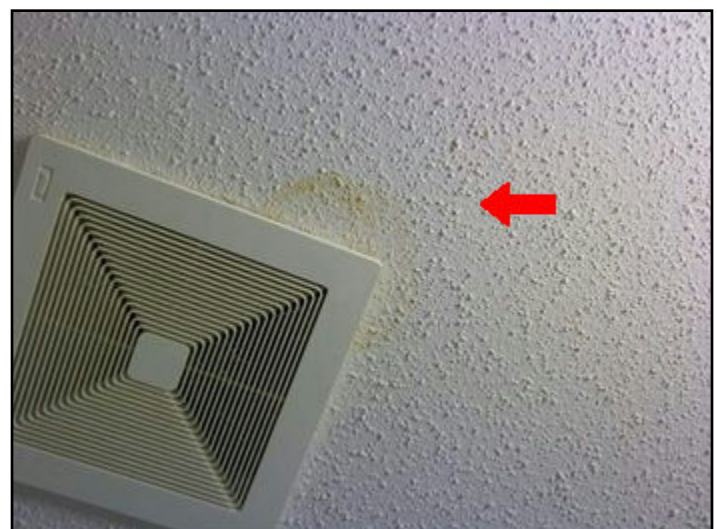
11. Condition: • Stain noticed by exhaust fan, monitor to see if changes due to weather or area increases. No leaks found and attic duct is well insulated.

Location: Second Floor Bathroom

Task: Monitor
