INSPECTION REPORT

For the Property at:
123 ANY STREET
MY TOWN, AB T0A3A0

Prepared for: SAMPLE REPORT
Inspection Date: Tuesday, May 1, 2012
Prepared by: Jeff Odowichuk

RE: Report No. 1003, v.0
123 Any Street
My Town, AB
T0A3A0

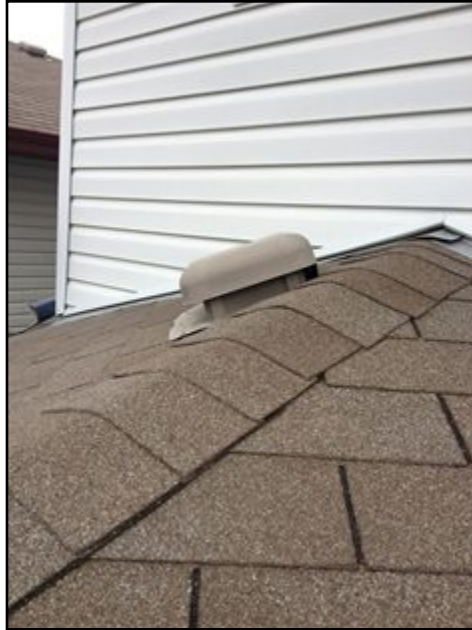
1. From roof edge

Inspection performed:

- From roof edge

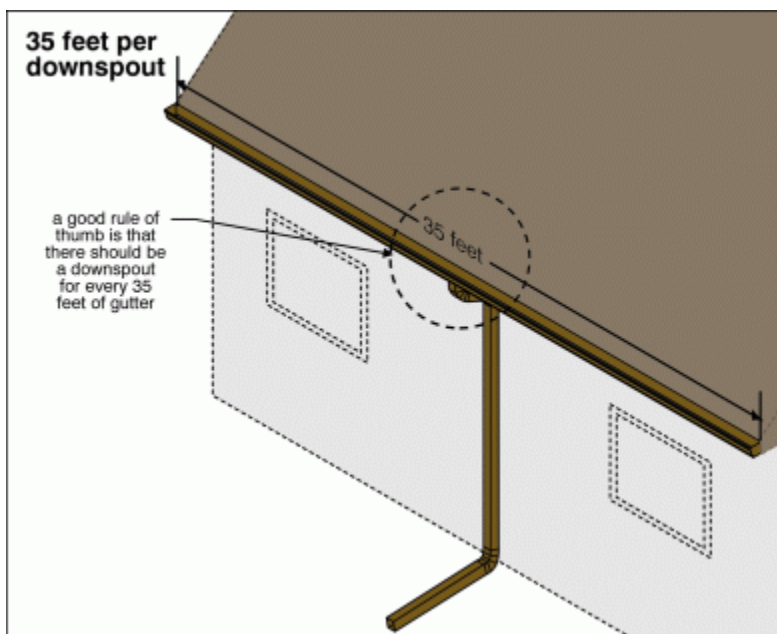
1. Condition: • [Missing](#)

Implication(s): Chance of water damage to contents, finishes and/or structure

Task: Replace

Time: Immediately

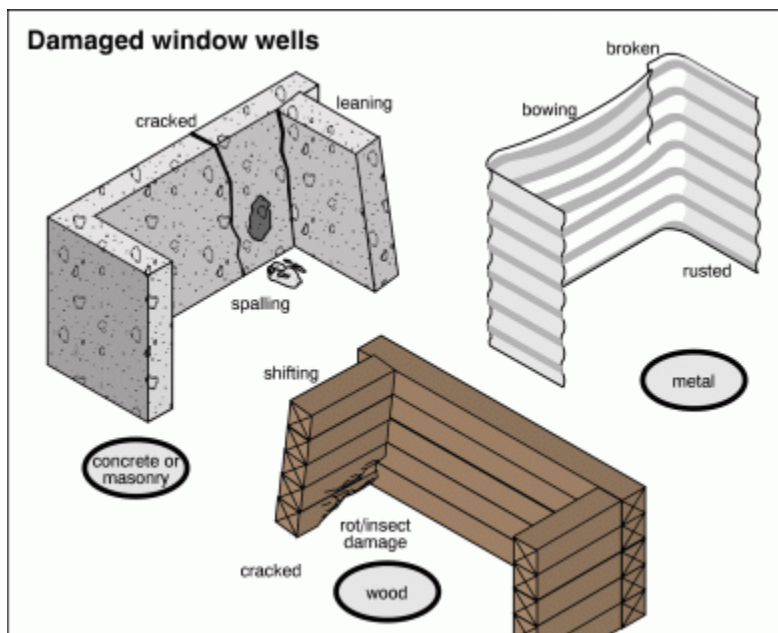
2. Condition: • [Damage](#)

Window well has been pushed in, Recommend repair

Implication(s): Chance of water damage to contents, finishes and/or structure | Material deterioration

Task: repair

Time: 6 months

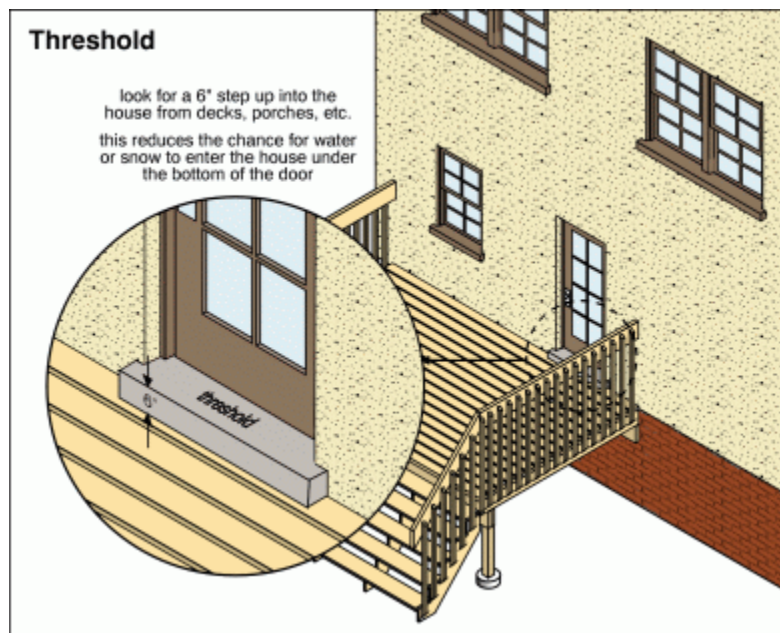
5. Condition: • [No step up into house](#)

Implication(s): Chance of water damage to contents, finishes and/or structure | Material deterioration

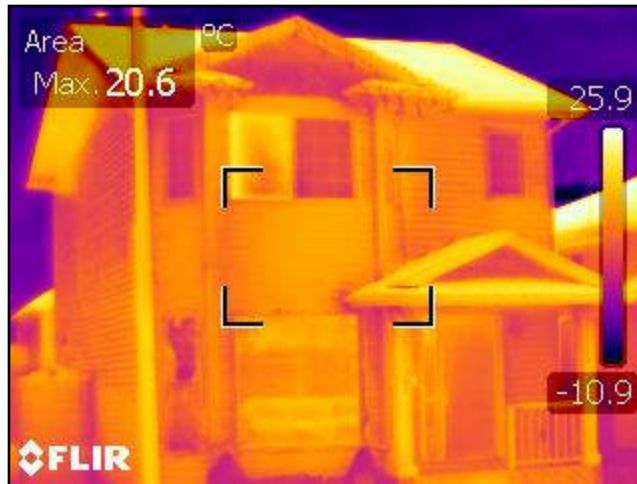
9. Wood frame

Exterior wall construction:

• [Wood frame](#)

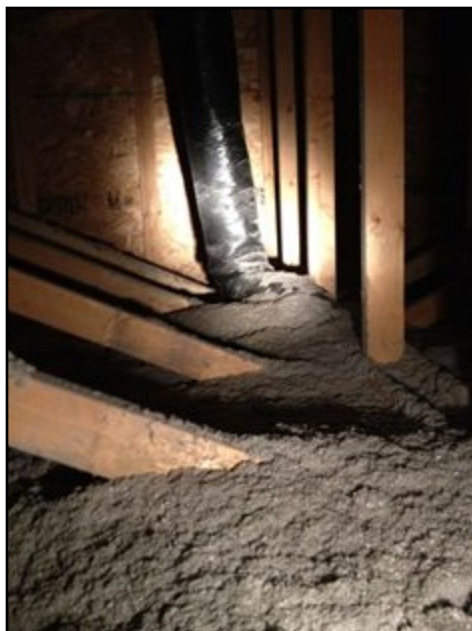
10. Inspected from access hatch

Attic/roof space:

• Inspected from access hatch

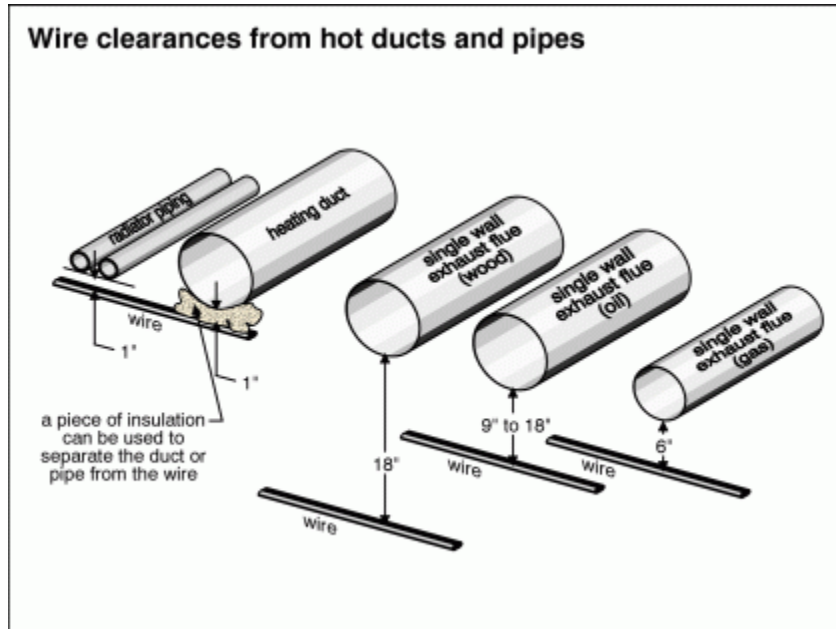
7. Condition: • [Too close to ducts, pipe, chimneys, etc.](#)

Implication(s): Electric shock | Fire hazard

Task: Repair

Time: Immediately

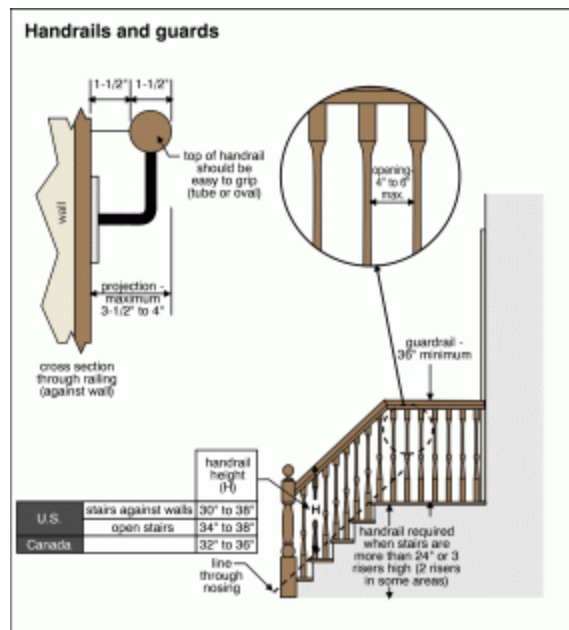
10. Condition: • [Missing](#)

Implication(s): Fall hazard

Task: Improve

Time: Immediate
